FIELD OVERSIGHT SUMMARY REPORT  
ACS NPL SITE  
GRIFFITH, INDIANA  
December 28, 1996 - February 5, 1997

**USEPA/ARCS V  
BVSPC Field Oversight Summary**

Reporting Period: December 28, 1996 - February 5, 1997 BVSPC Project No. 71670

Site Name/Location: ACS, Grifth, IN

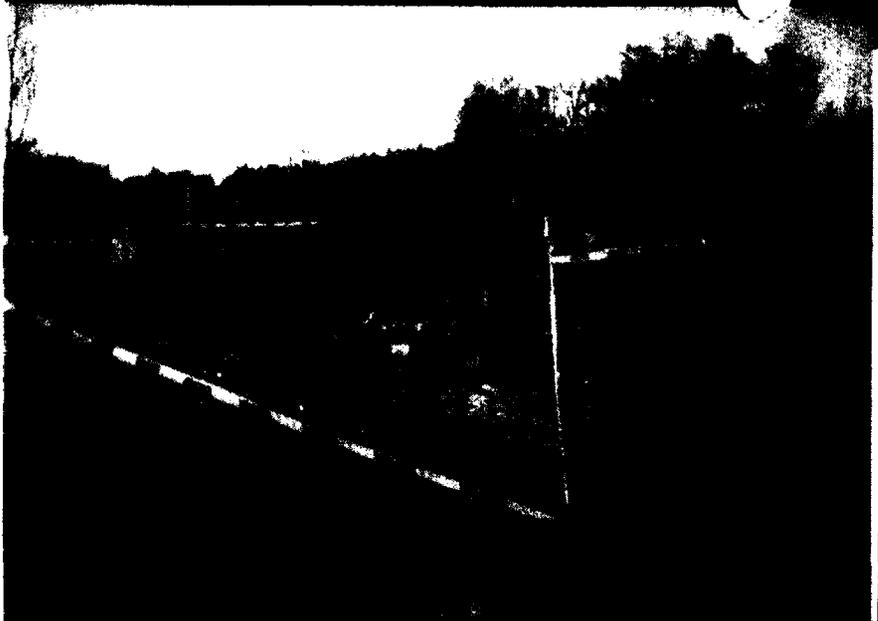
Site: American Chemical Services, Inc. RDEFA

Description: Facing north-east. The drums shown in Photo #3 and Photo #4 were temporarily covered with plastic and staked within buried waste spoils management area (BWSMA) set up in accordance with the spoils management plan(SMP).

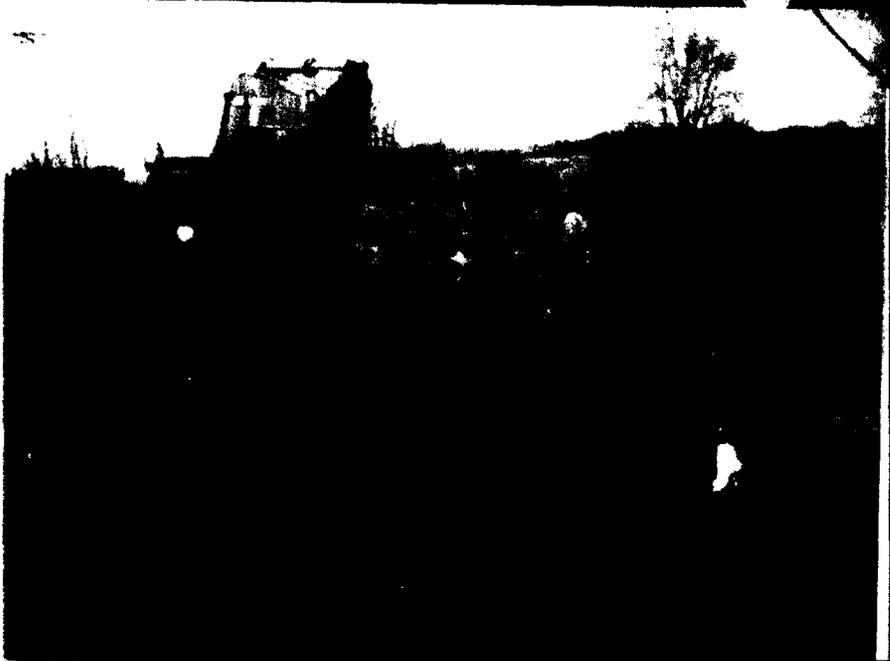
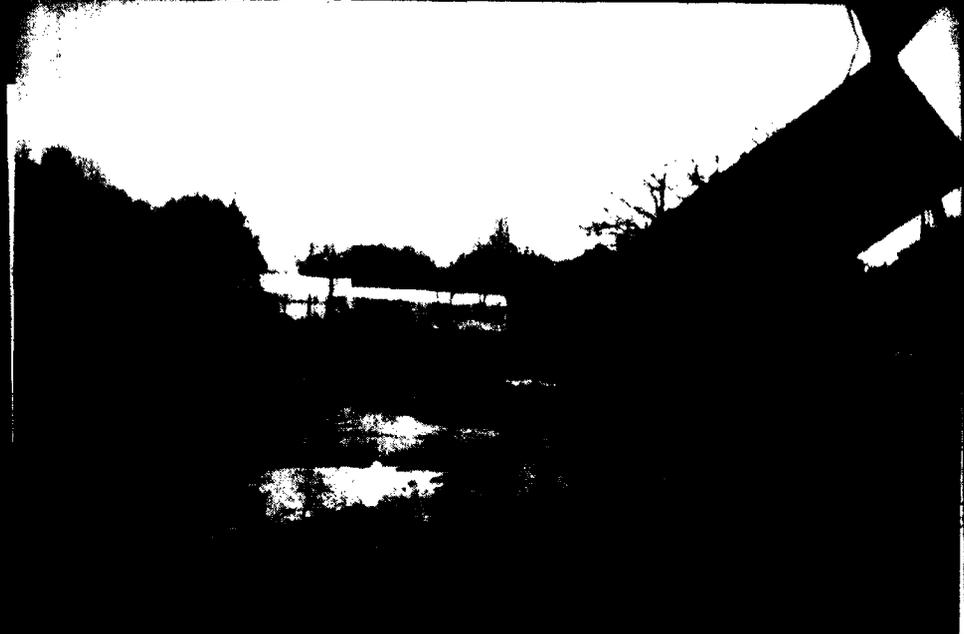
Site: American Chemical Services, Inc. RIDGERS

Description: Facing east. The excess soils/municipal waste generated during excavation for BWES conveyance piping are to be placed within the upper aquifer soils management area (UASMA) set up in accordance with the SMP.

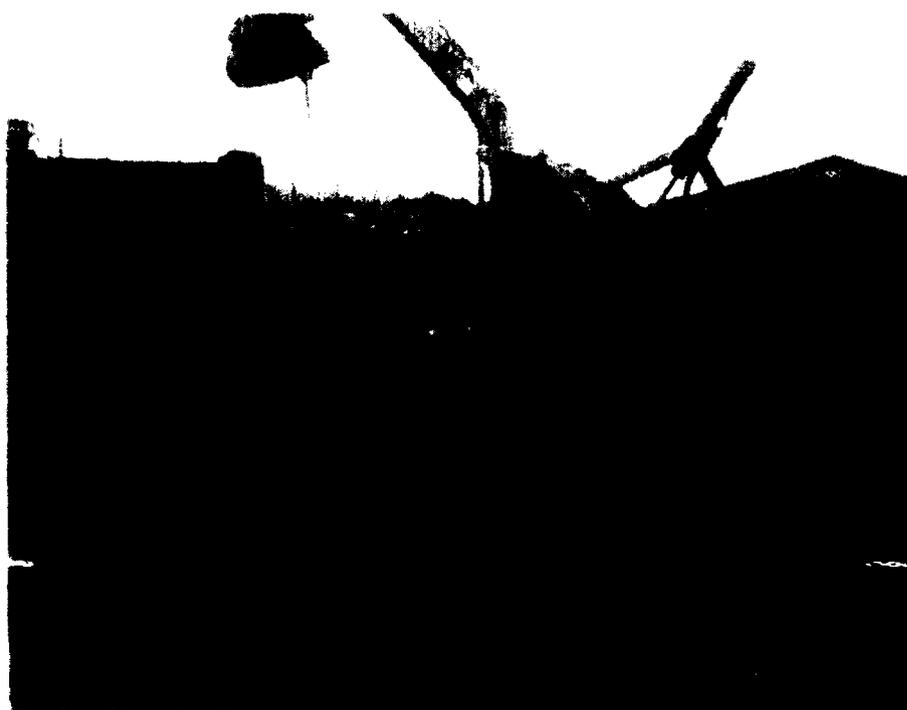
Site: American Chemical Services, Inc. RD-FRA  
Prop #: 71670,600

Description: Facing south-east. The excess soils/municipal waste generated during excavation for BWES conveyance piping are being loaded on to the haul truck for transport to the CASMA set up in accordance with the SMP. The backfilling of the excavation continued simultaneously.

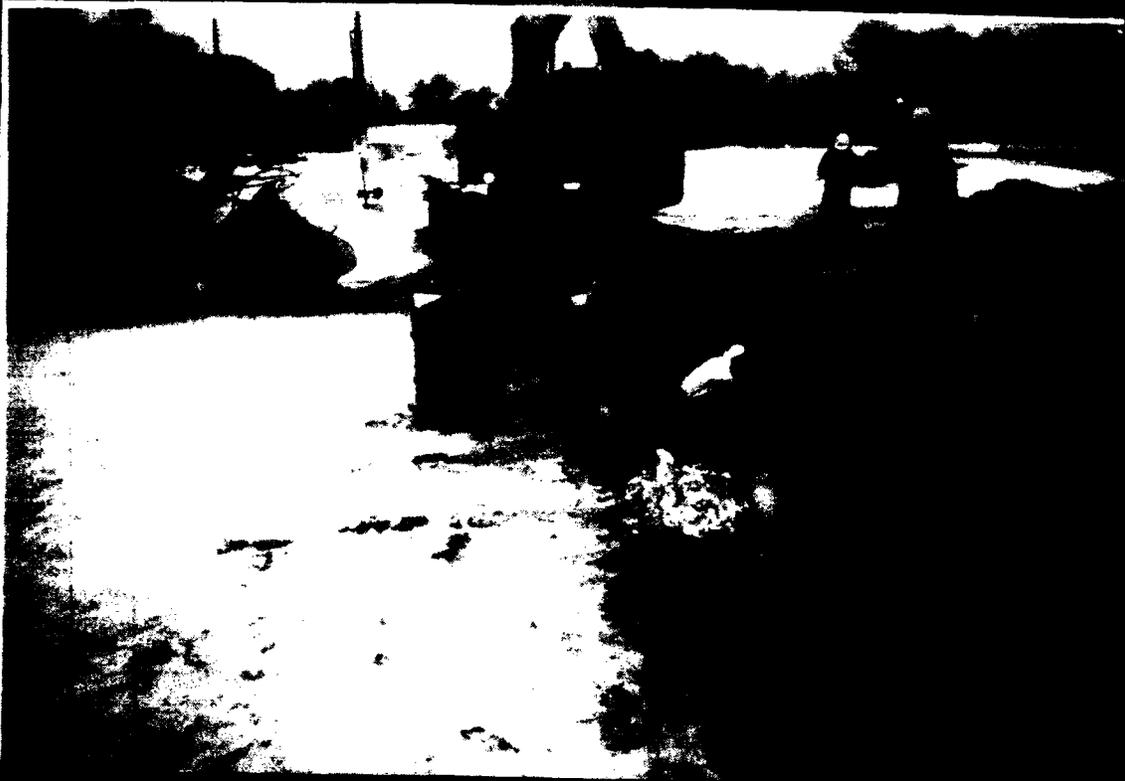
Site: American Chemical Services, Inc. RD/ERA  
Proj. #: 71670.600  
Roll: 5 Photo #: 21  
Date: 01-21-97 Time: 1115  
Photographer: Ashok Rupani  
Description: Facing west. Installing water line BWES conveyance  
piping inside the ACS facility.

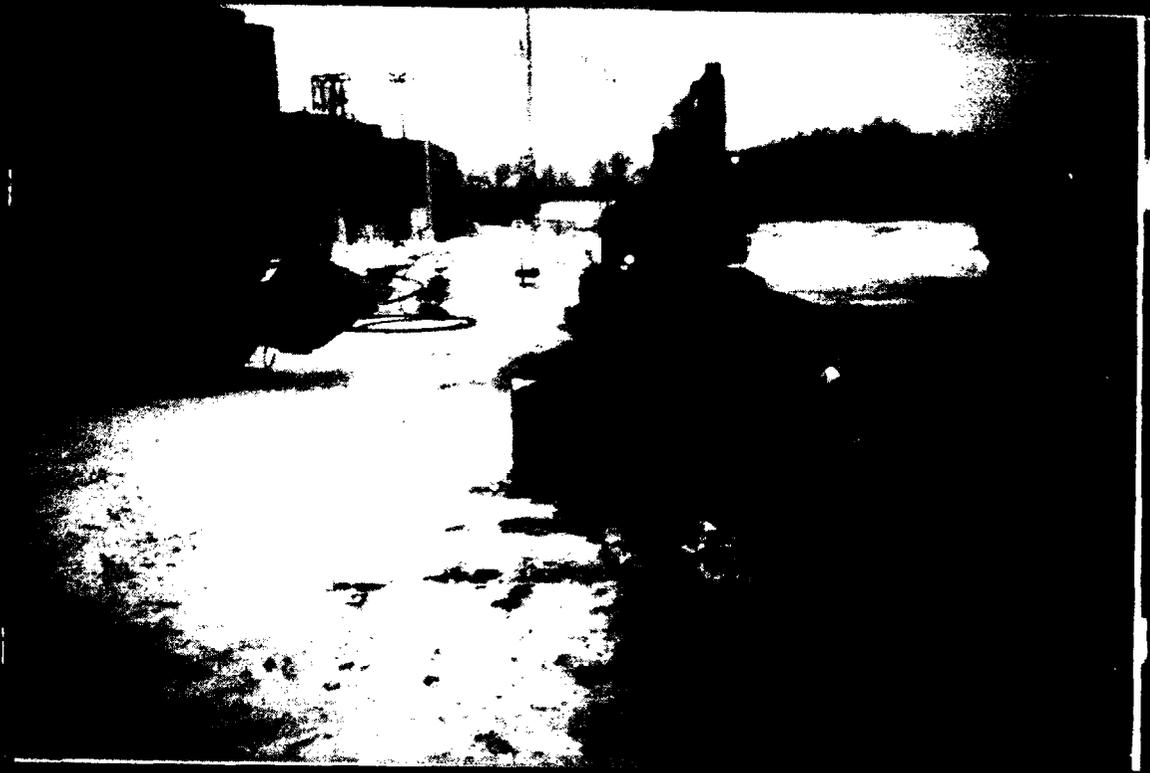
Site: An... Chemical Services, Inc. RD-FRA  
Proj. #: 71640.000  
Roll: 3 Photo #: 22  
Date: 01-21-97 Time: 1115  
Photographer: Ashok Rupani  
Description: Facing west. Installing water line BWIS conveyance  
piping inside the ACS facility.

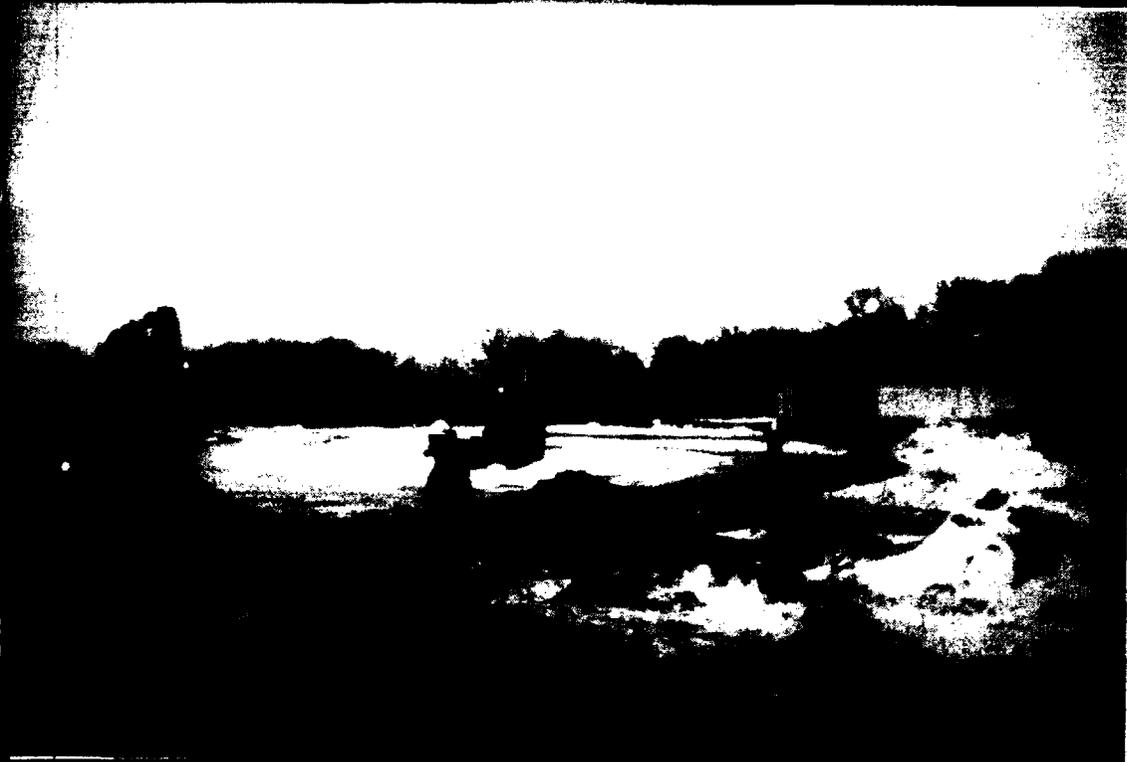
Sac. American Chemical Services, Inc. RD/ERA  
Proj. #: 71670,600  
Roll: 3 Photo #: 23  
Date: 01-21-97 Time: 1115  
Photographer: Ashok Rupani  
Description: Facing west. Installing water line/BWIS conveyance  
piping inside the ACS facility

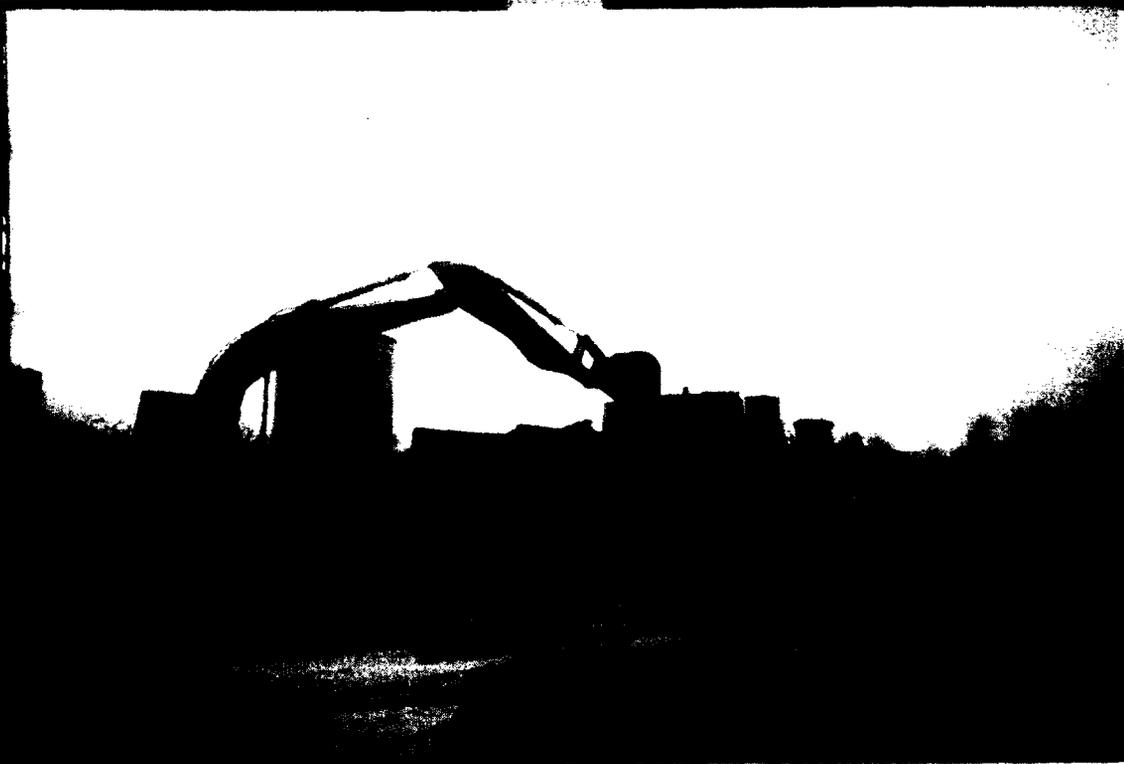
Site: American Chemical Services, Inc. RD-FRA  
Proj. #: 71670,600  
Roll: 3 Photo #: 24  
Date: 01-21-97 Time: 1:15  
Photographer: Ashok Rupani  
Description: Facing north-west. Installing water line BWFS  
conveyance pipe inside the ACS facility.

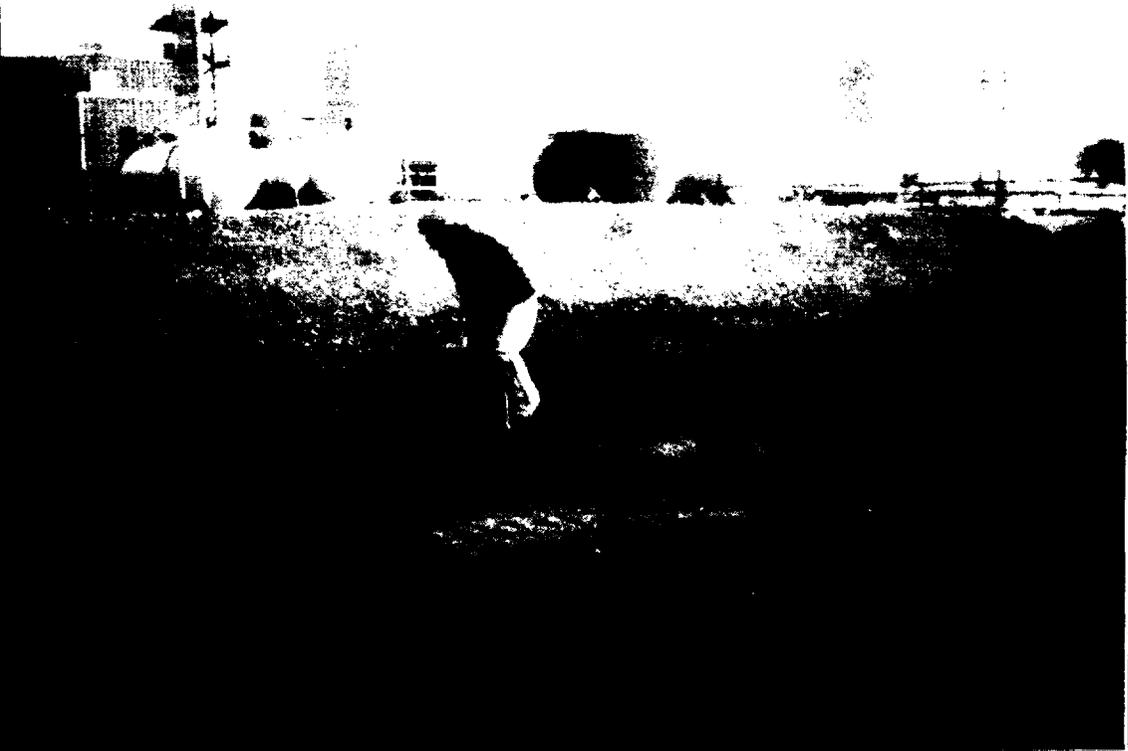
Description: Facing south-east. Loading the haul truck with excess soils generated during water line DWIS conveyance piping installation just east of the fence located along the western side of the ACS facility.

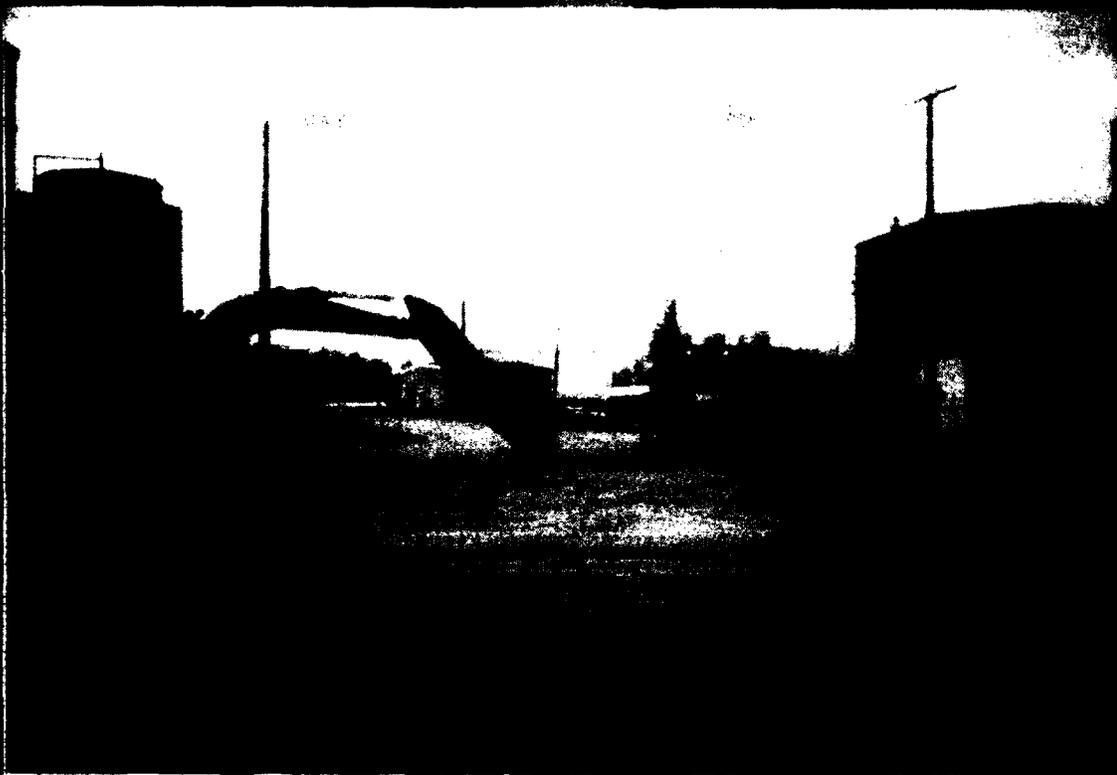
Site: American Chemical Services, Inc. RDEFA  
Proj. #: 71670,600  
Roll: 3 Photo #: 26  
Date: 01-23-97 Time: 1530  
Photographer: Ashok Rupani  
Description: Facing east. Compacting the sand backfill in the BWIS  
conveyance piping trench installed just east of the fence  
located along the western side of the ACS facility.

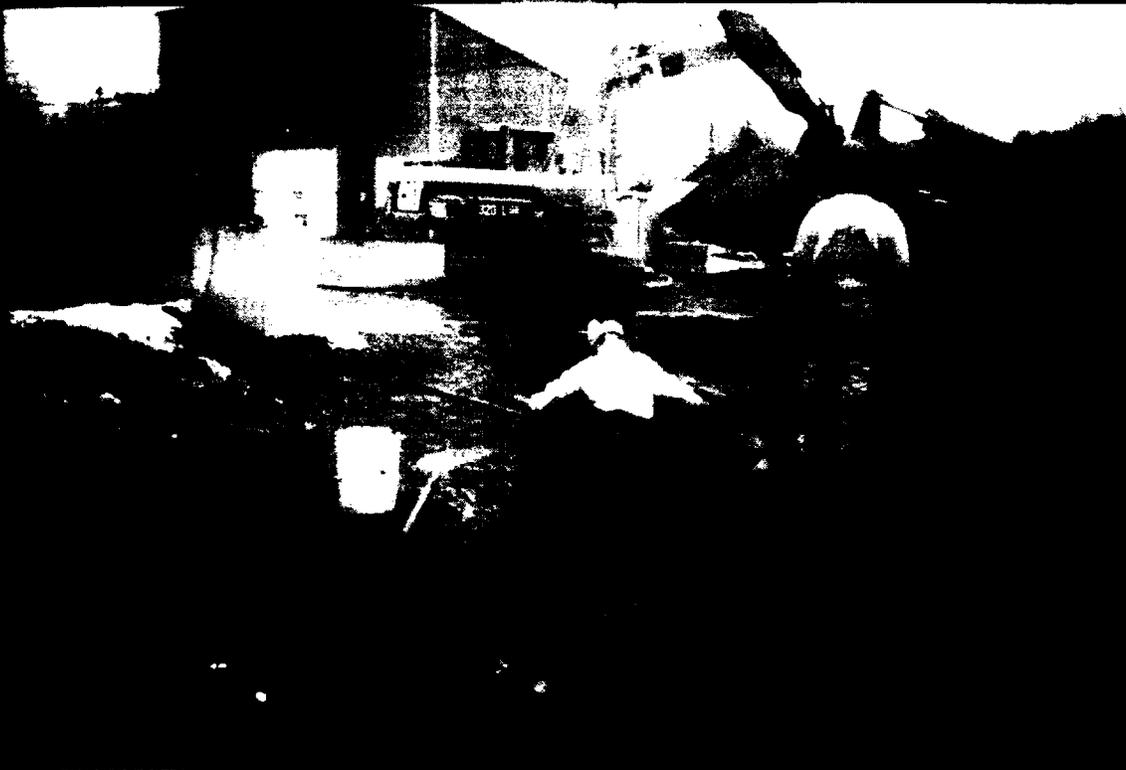
Site: American Chemical Services, Inc. RD/ERA  
Proj. #: 71670.600  
Roll: 3 Photo #: 29  
Date: 01-24-97 Time: 1045  
Photographer: Ashok Rupani  
Description: Facing south-west. Backfilling the water line:BWES  
conveyance piping trench with gravel.

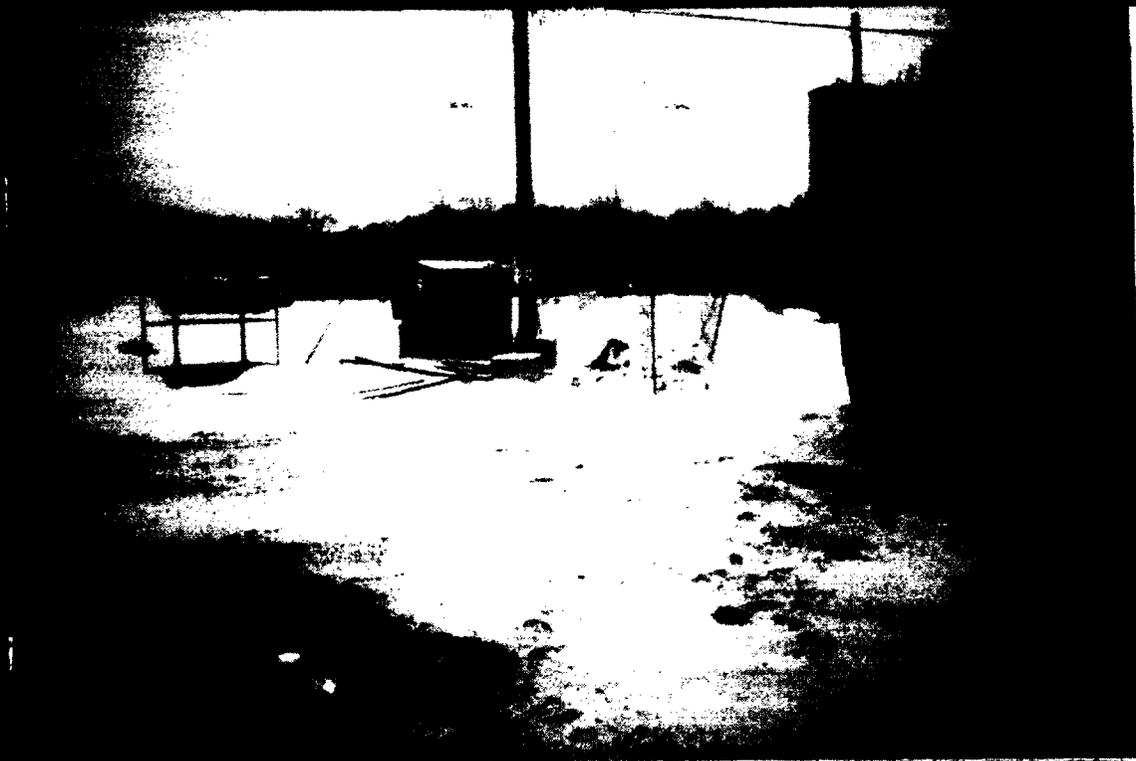
Site: American Chemical Services, Inc. RD:ERA

Description: Facing south. Drums were encountered in this area during installation of water line/BWES conveyance piping. This area was temporarily fenced for safety reasons.

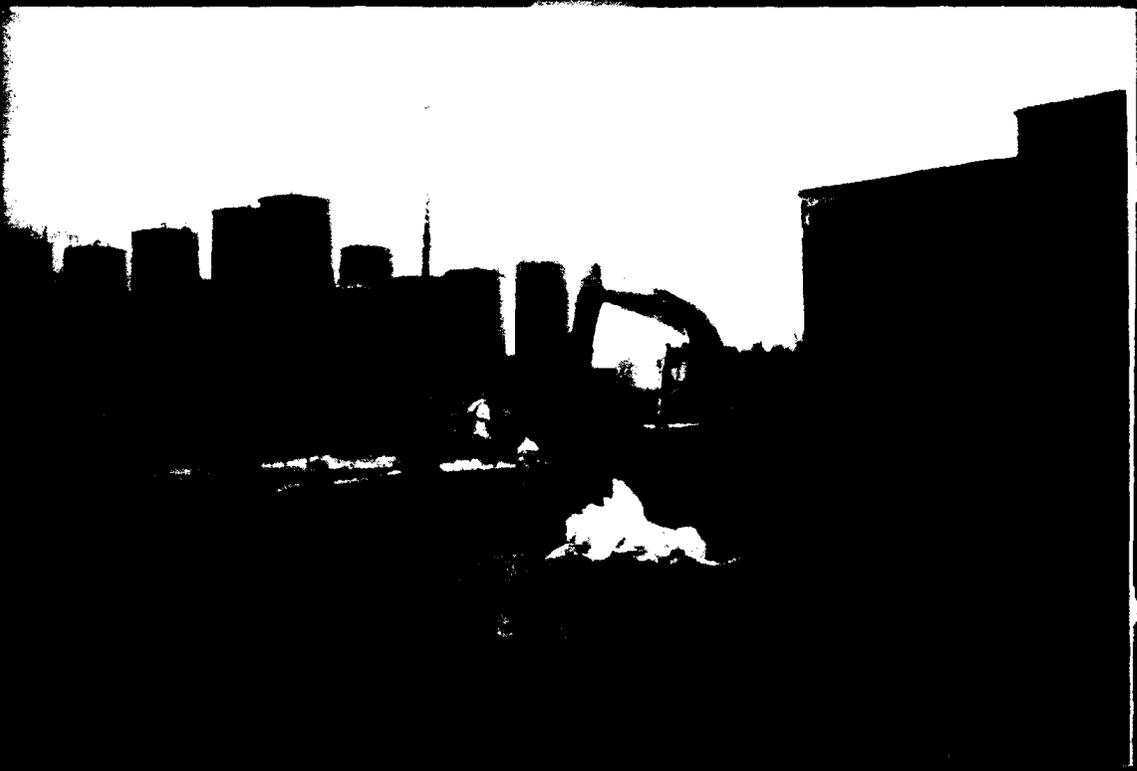
Site: American Chemical Services, Inc. RDI RA  
Proj. #: 71670,600  
Roll: 4 Photo #: 32  
Date: 02-01-97 Time: 1500  
Photographer: Ashok Rupani  
Description: Facing south-east. Drum removal and overpacking  
activities being conducted in the area shown in Photo  
#31.

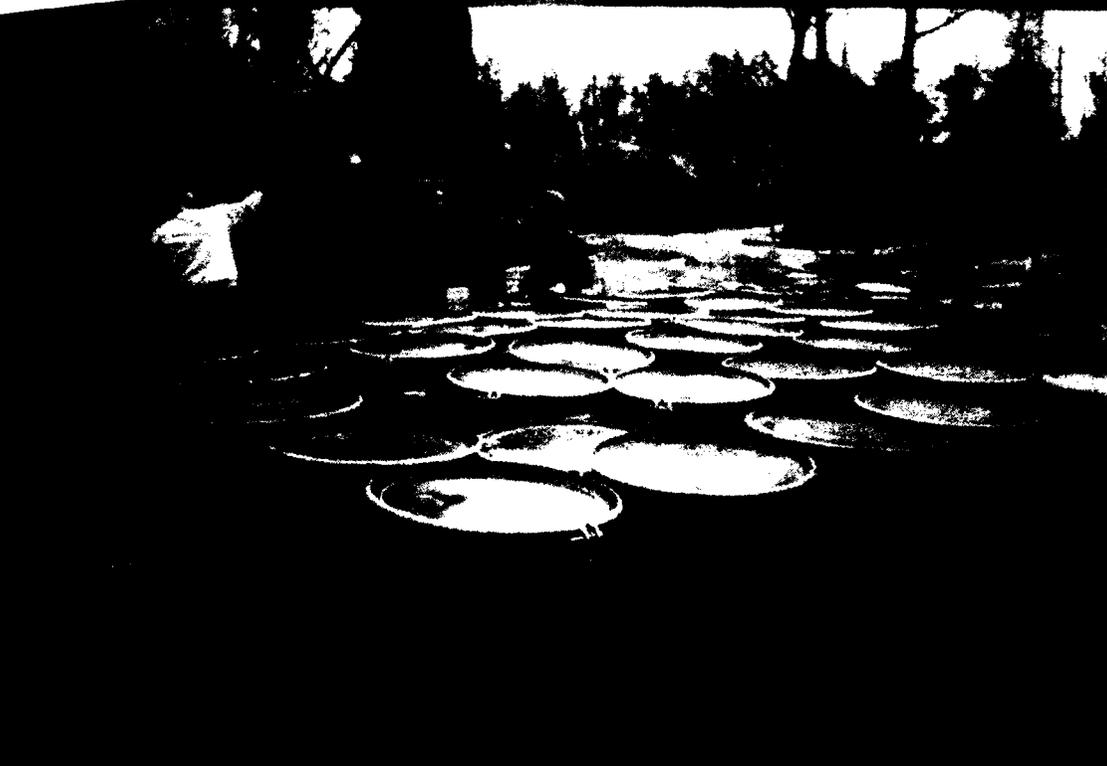
Site: American Chemical Services, Inc. RD/ERA  
Proj. #: 71670.c.c.  
Roll: 4 Photo #: 39  
Date: 02-03-97 Time: 1340  
Photographer: Ashok Rupani  
Description: Facing south. Drums shown in Photo #34 are being placed in the drum staging area.

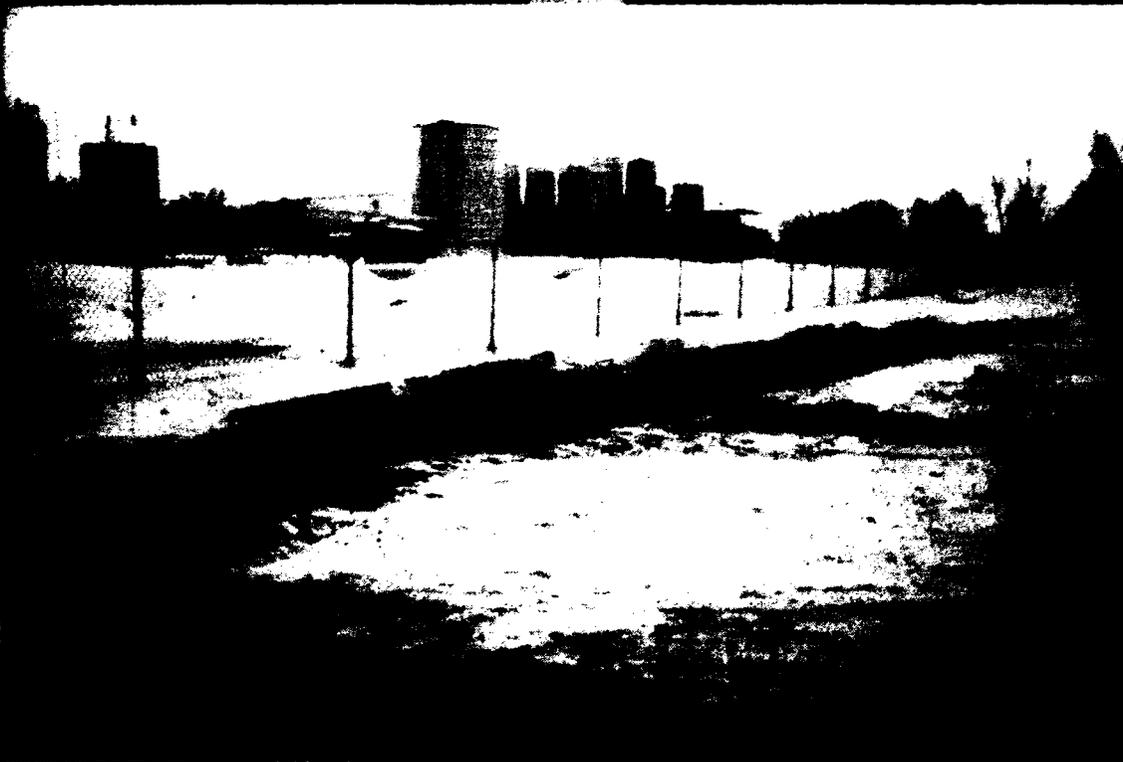
Site: American Chemical Services, Inc. RD/ERA  
Proj. #: 71670.600  
Roll: 3 Photo #: 41  
Date: 01-27-97 Time: 1310  
Photographer: Ashok Rupani  
Description: Facing south-west. Excavating to install water line/BWES conveyance piping just west of the drum area inside the ACS facility shown in Photo #51

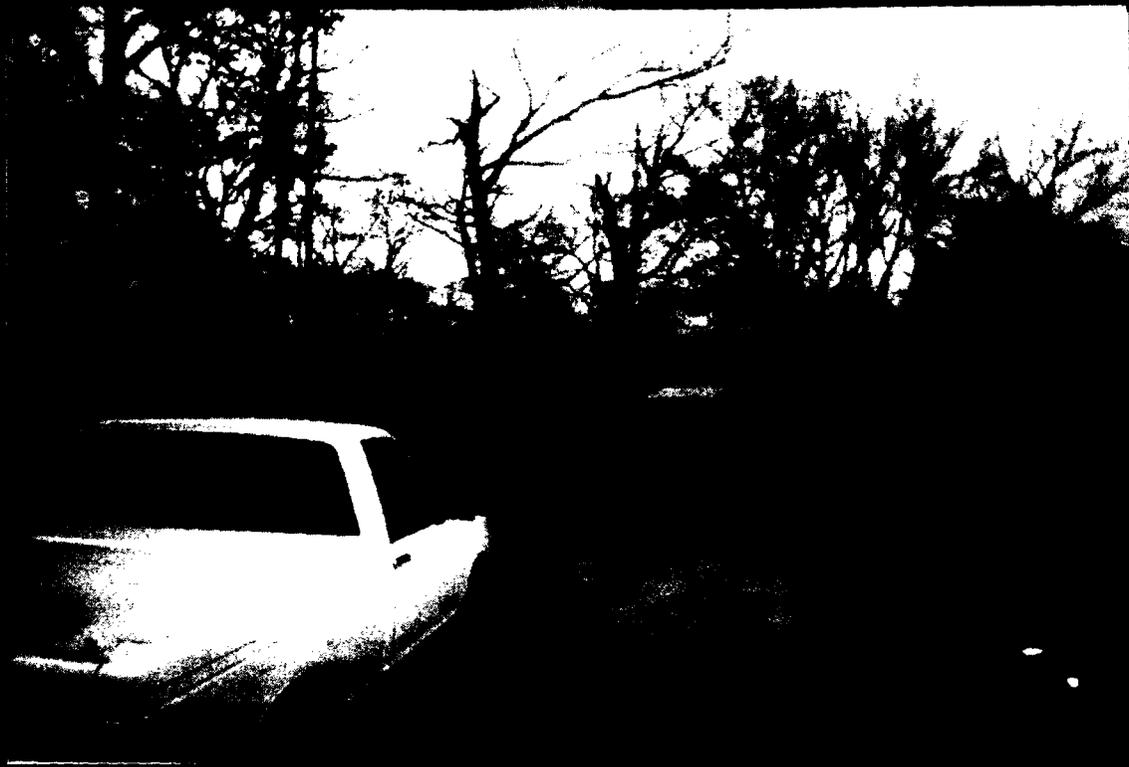
Description: Facing west. Installing central section of the PGCS extraction trench.
